Firm credentials and case studies

4. Project Name: Delhi Golf Course, New Delhi

Location: New Delhi

Duration: July 2020- Present

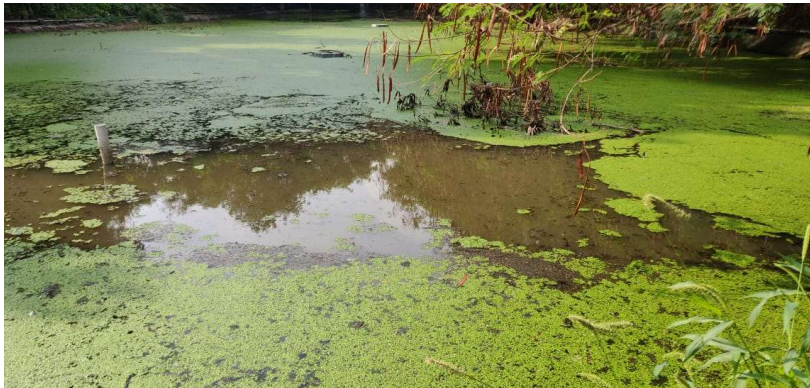
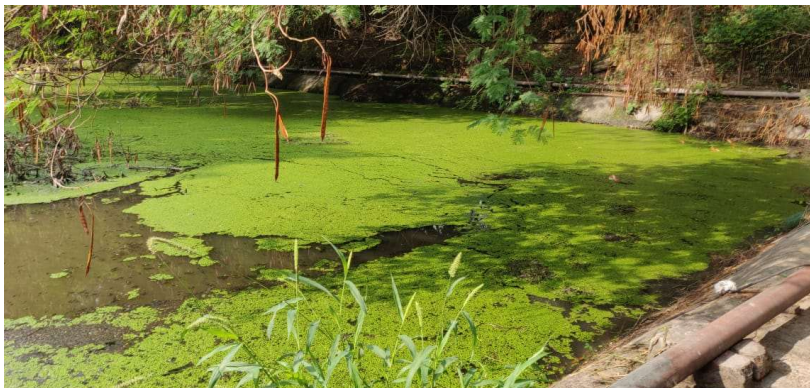
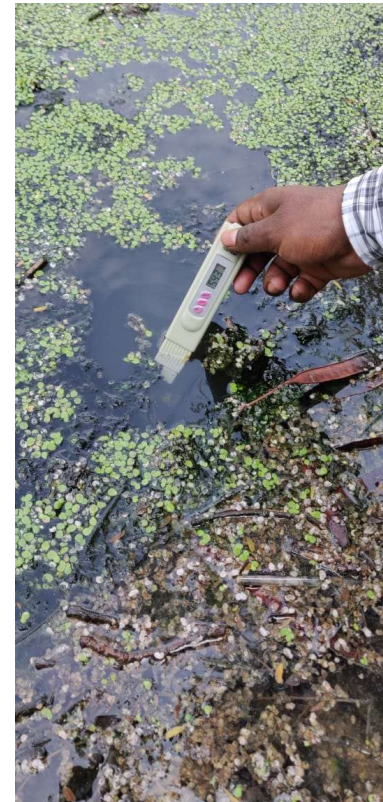
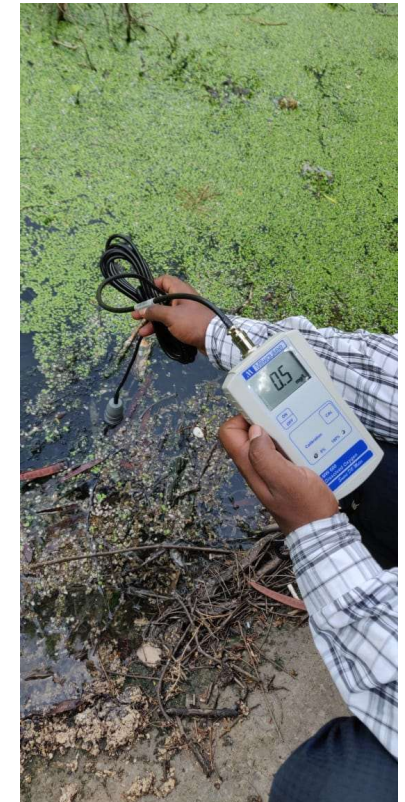
- Water body condition before OXYFEED treatment.
- Pictures were taken on June 22, 2020.

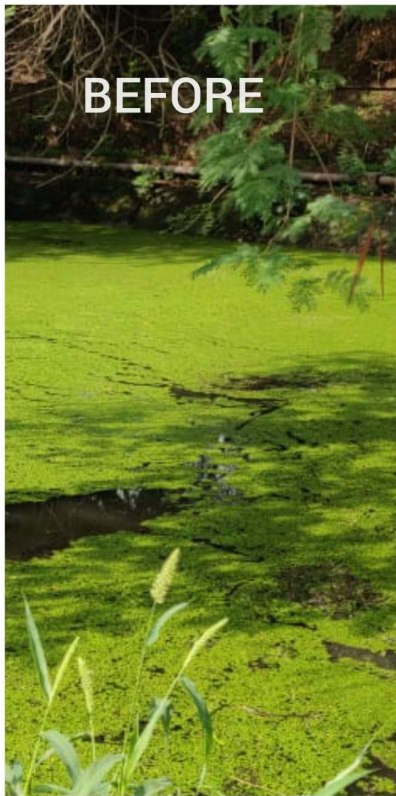
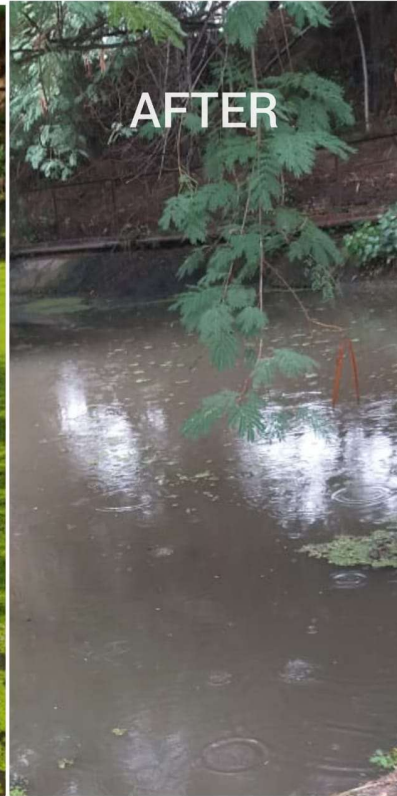
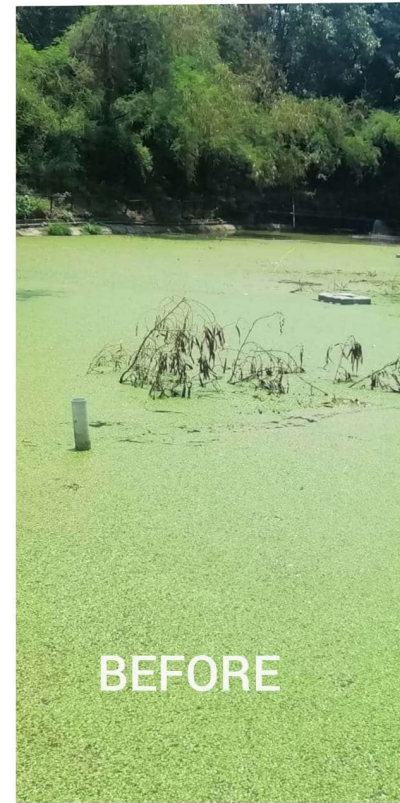
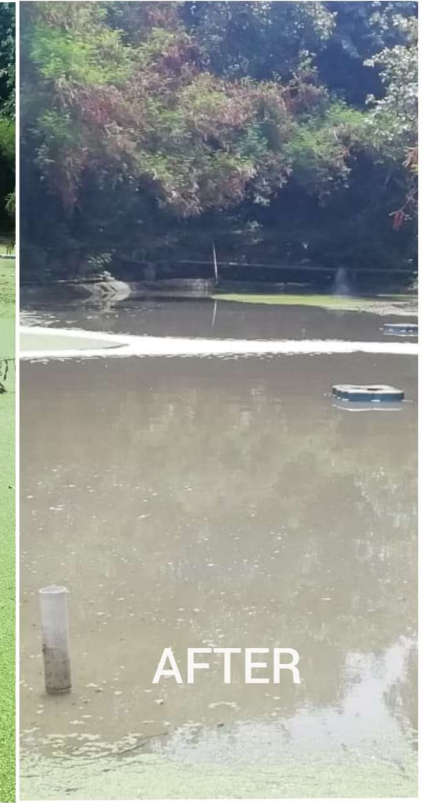
- After first dosing of OXYFEED treatment.
- Development on June 24, 2020.

- Initially the sludge was removed from the pond and Aquaritin is dosed regularly.
- Water Quality is monitored on monthly basis.
